MEMORANDUM

SUBJECT: Site Assessment: Certain-Teed Transite Pipe
A.K.A Maline Creek, 600 St. Cyr Road, St. Louis, Missouri
TDD#: T07-9203-012
PAN#: EM00307SAA
EPA/OSC: Mark Roberts

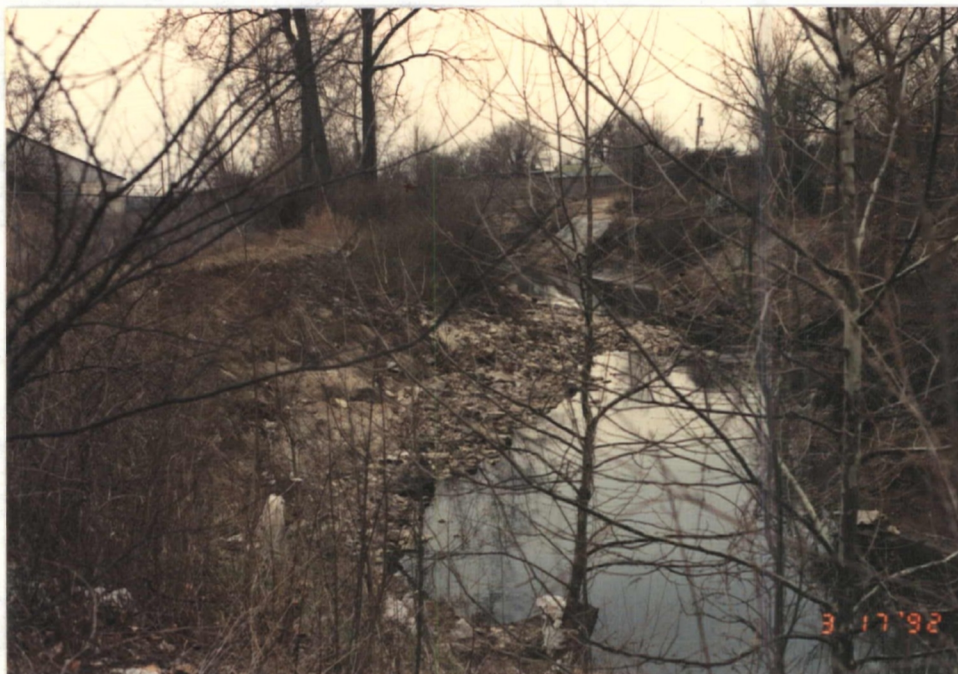
Photographer: Joe Parish
Date/Time : 3/17/92/1215
Lens: Type: 50mm/normal
Serial No.: 1063023
Frame No. : 1
Direction : E
Comments :
South of former GAF, north
bank of creek

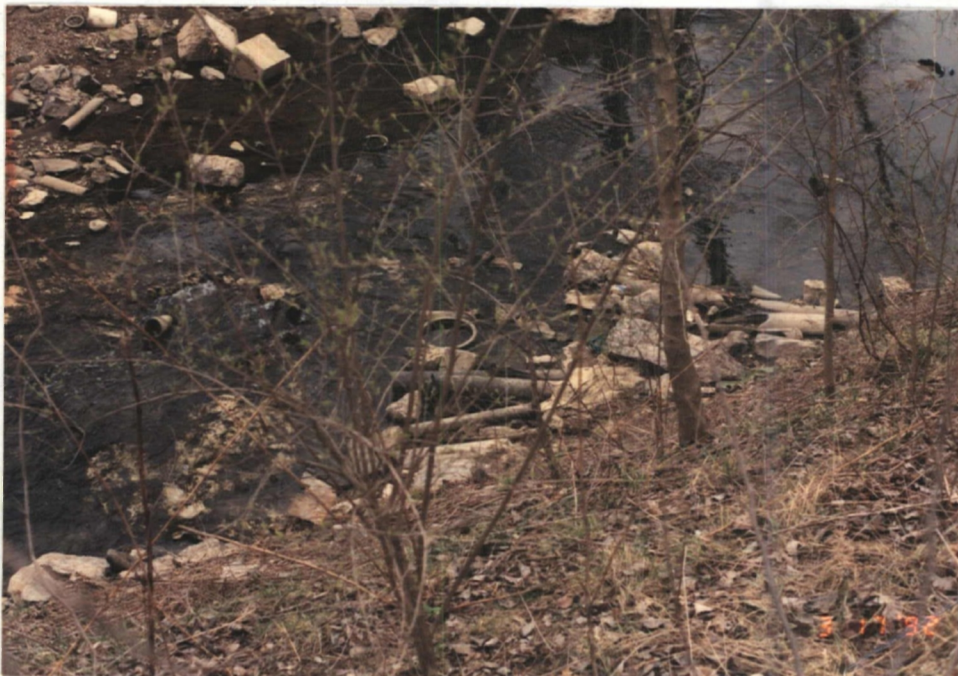
Photographer: Joe Parish
Date/Time : 3/17/92/1217
Lens: Type: 50mm/normal
Serial No.: 1063023
Frame No. : 2
Direction : S
Comments :
North edge of creek, SW of
Certain-Teed

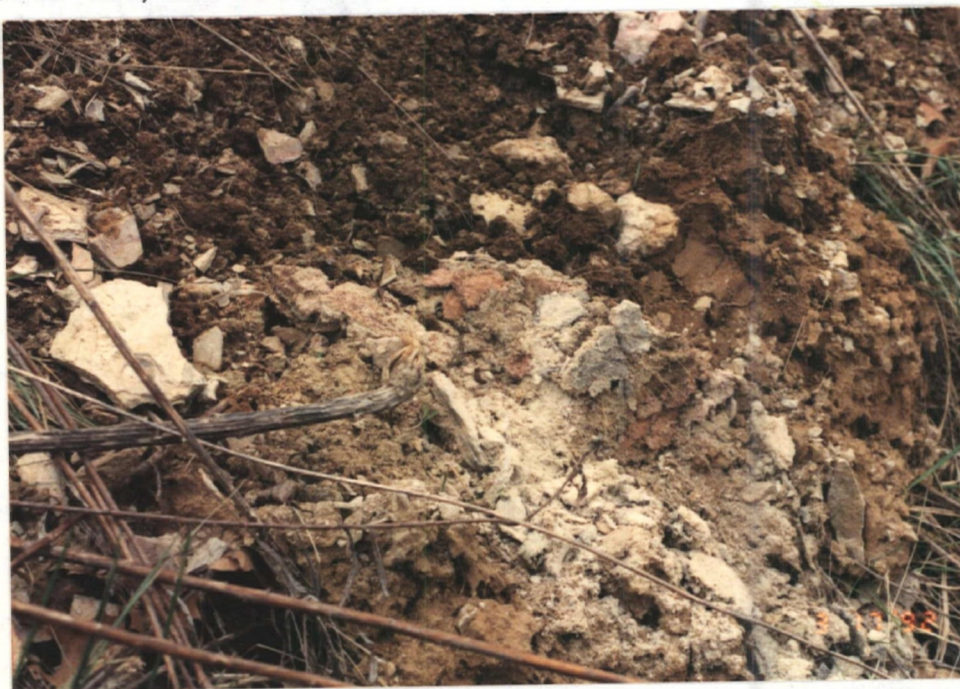
to be sheeting was visible in the rip-rap area. What appeared to be insulation material had been exposed by erosion at the upper bank of the creek. Both this material and the sheeting were sampled (sample numbers 005 and 006, see the site map for location). The insulation material was friable and particles became airborne during sample collection. The sheeting appeared hard, stable, non-friable, and was sparsely scattered throughout the rip-rap.

Photographer: Joe Parish
Date/Time : 3/17/92/1220
Lens: Type: 50mm/normal
Serial No.: 1063023
Frame No. : 3
Direction : SE
Comments :
North bank, apparent
insulation, sample 5 location

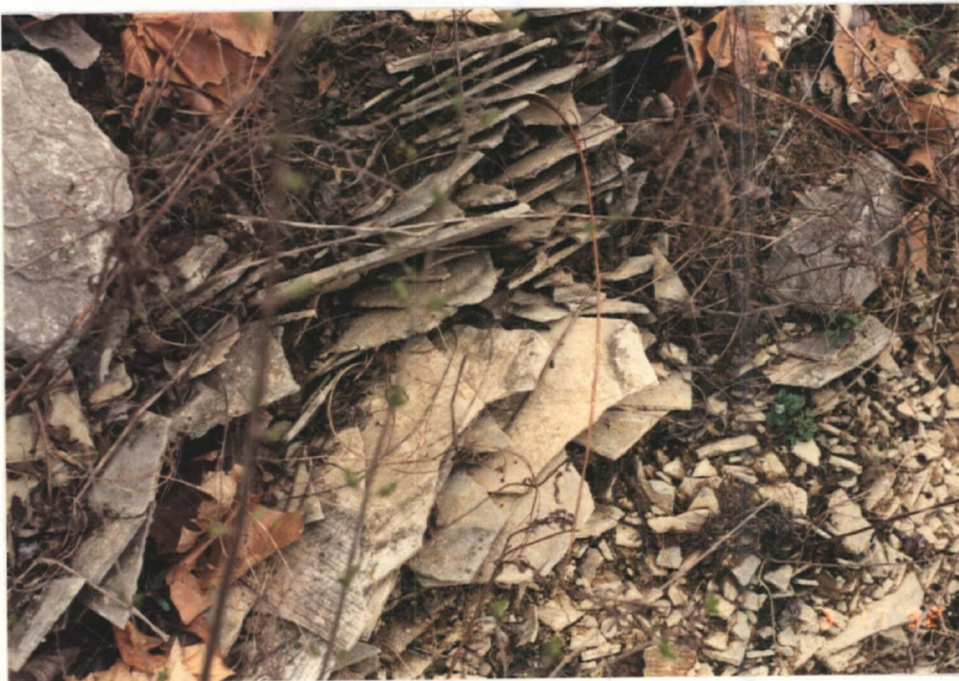
Photographer: Joe Parish
Date/Time : 3/17/92/1230
Lens: Type: 50mm/normal
Serial No.: 1063023
Frame No. : 4
Direction : SE
Comments :
North bank, sample 6 location

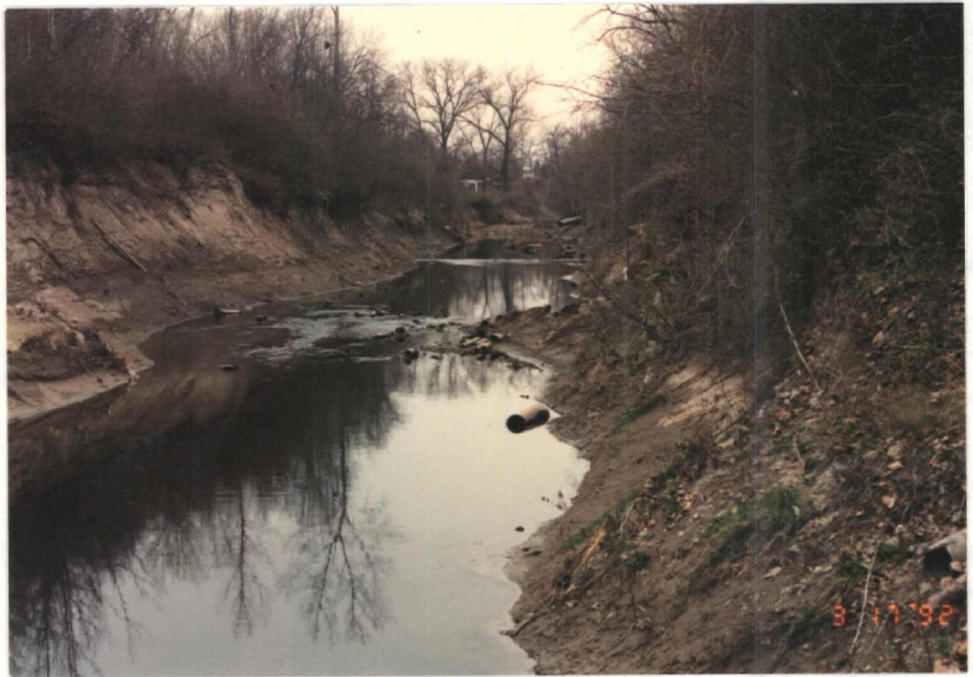
Next, TAT walked along the upper and lower banks of Maline Creek. TAT observed large quantities of transite pipe scrap material scattered down to the creek bed and extending downstream to approximately the neighboring property boundary. The upper bank of the creek appeared to be eroding, exposing more transite pipe scrap. The scrap material appeared to derive from a berm built up along the edge of the upper creek bank, presumed to cover the transite scrap. Sample number 003 was taken at this location (see site map). Transite pipe was scattered on both the near and far banks of the creek, as well as in the creek bed. A composite sample (number 004) was collected from material at these locations. The transite scrap appeared to be in two forms - scrap of the pipe itself, and scrap of the ring connectors that joined the pipe sections. The connectors were slightly friable. The pipe scrap was very hard and could only be broken by using a sledge hammer. In either case, fibers were observed sticking out of the weathered broken edges of pipe scrap.

Photographer: Dave Kinroth
Date/Time : 3/17/92/1240
Lens: Type: 50mm/normal
Serial No.: 1063023
Frame No. : 5
Direction : NW
Comments :
Transite pipe and connectors,
north creek bank south of
former Certain-Teed

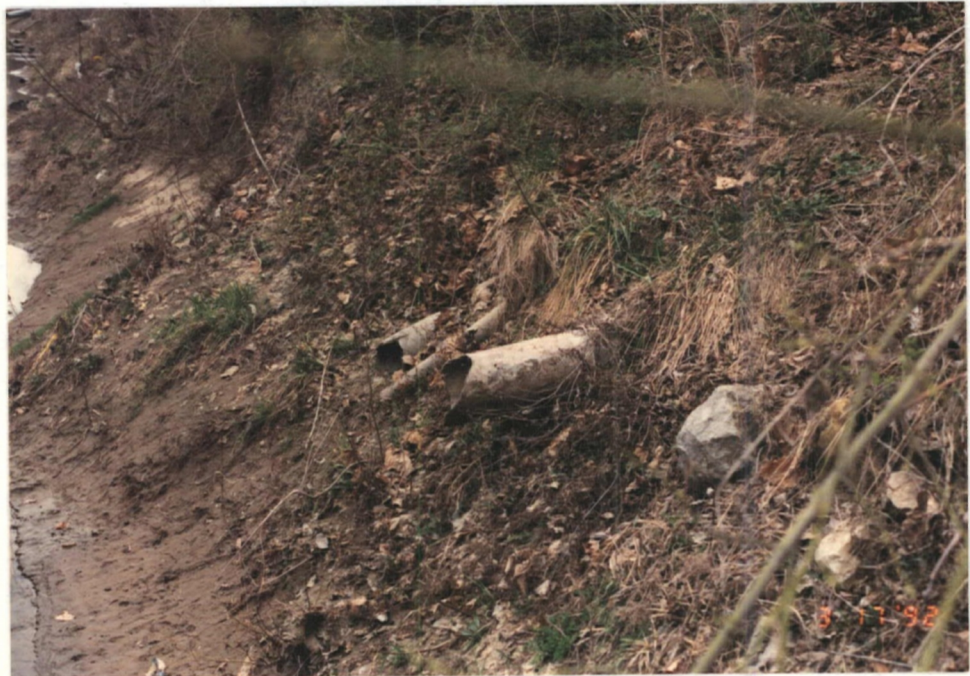
Photographer: Dave Kinroth
Date/Time : 3/17/92/1241
Lens: Type: 50mm/normal
Serial No.: 1063023
Frame No. : 6
Direction : NW
Comments :
Transite pipe and connectors,
north creek bank south of
former Certain-Teed

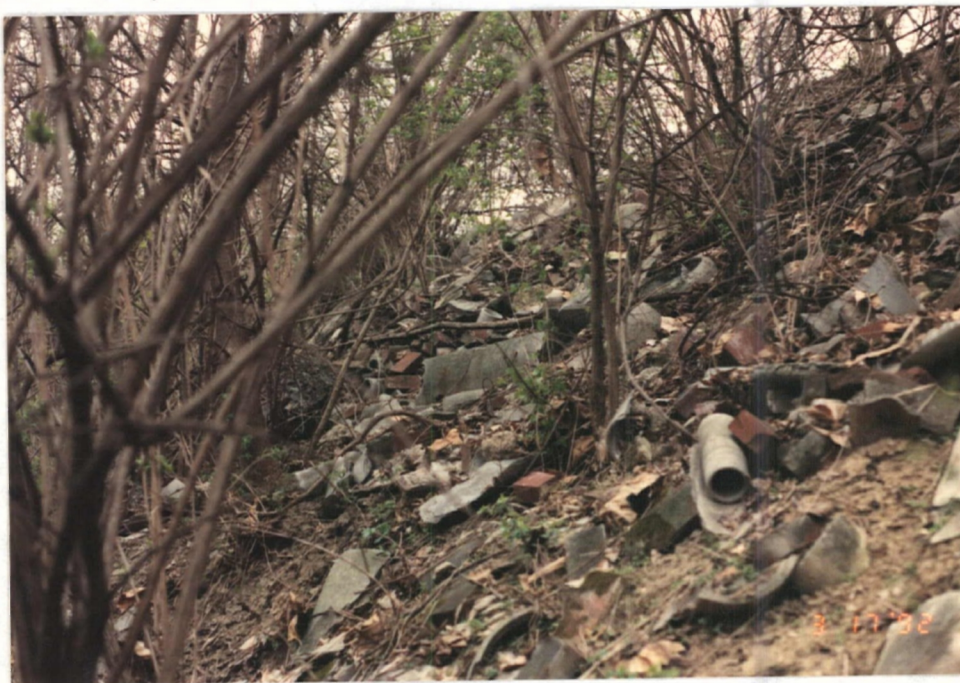
Frame No. : 7

Transite pipe and connectors,
north creek bank south of
former Certain-Teed

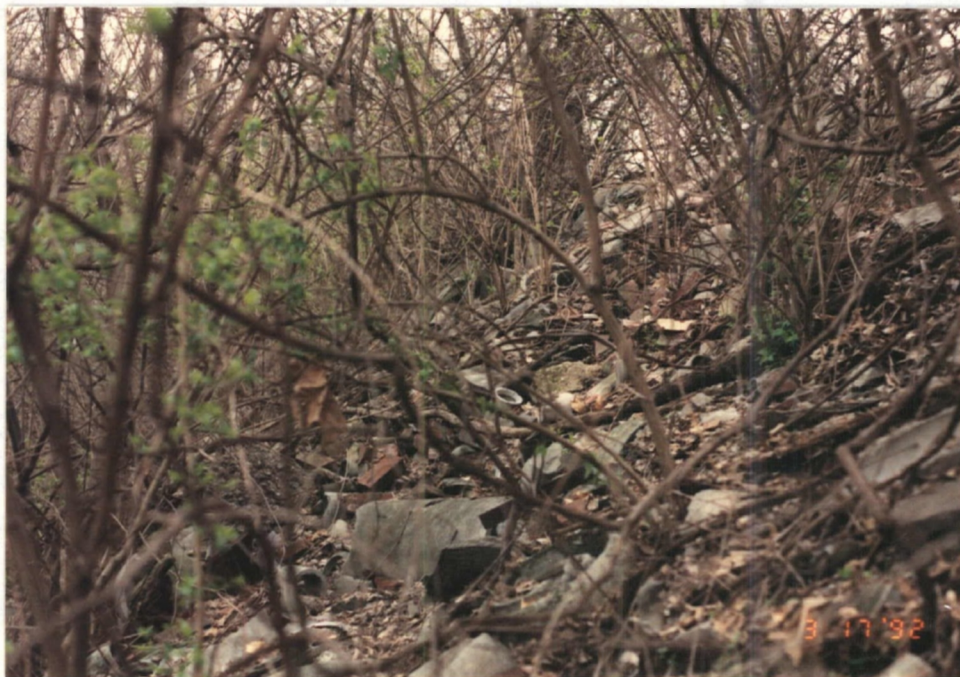
Frame No. : 8

Transite pipe and connectors,
north creek bank south of
former Certain-Teed

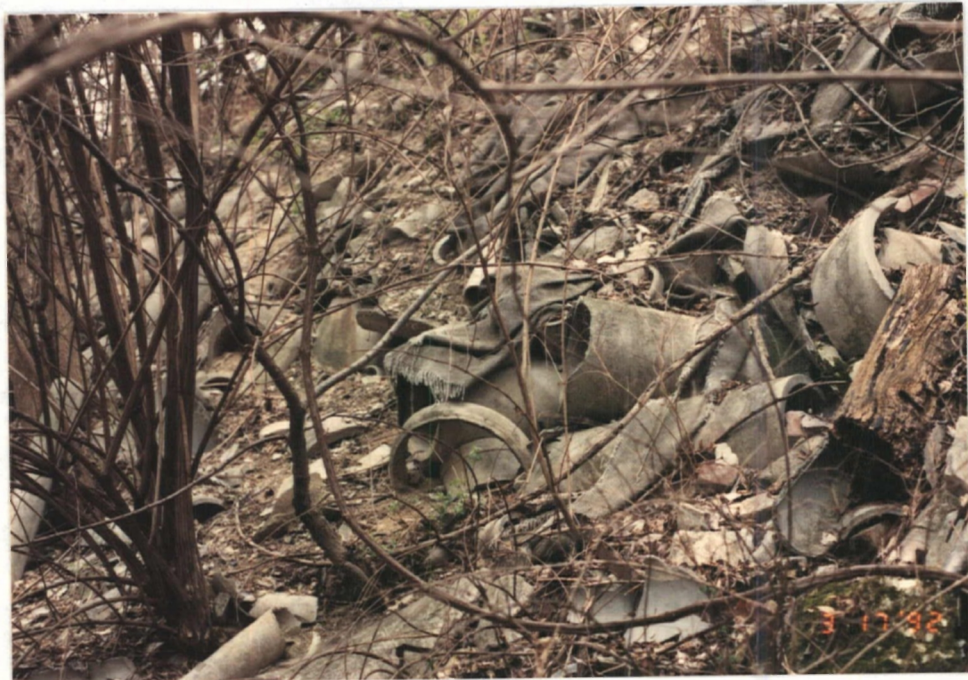
Photographer: Dave Kinroth
Date/Time : 3/17/92/1243
Lens: Type: 50mm/normal
Serial No.: 1063023
Frame No. : 9
Direction : NW
Comments :
Transite pipe and connectors,
north creek bank south of
former Certain-Teed

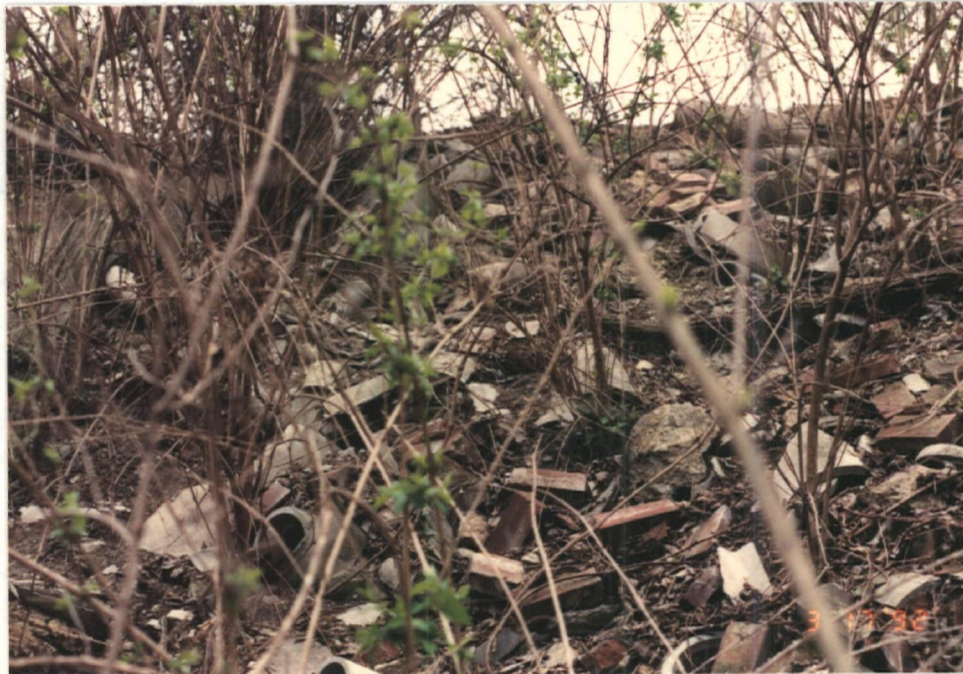
Photographer: Dave Kinroth
Date/Time : 3/17/92/1244
Lens: Type: 50mm/normal
Serial No.: 1063023
Frame No. : 10
Direction : NW
Comments :
Transite pipe and connectors,
north creek bank south of
former Certain-Teed

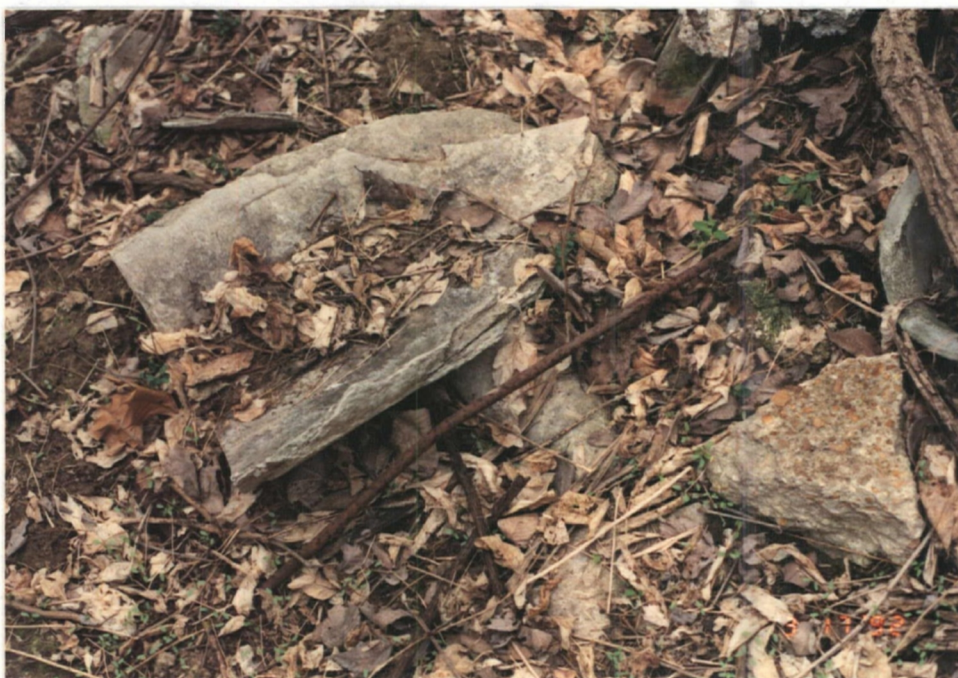
Photographer: Dave Kinroth
Date/Time : 3/17/92/1245
Lens: Type: 50mm/normal
Serial No.: 1063023
Frame No. : 11
Direction : NW
Comments :
Transite pipe and connectors,
north creek bank south of
former Certain-Teed

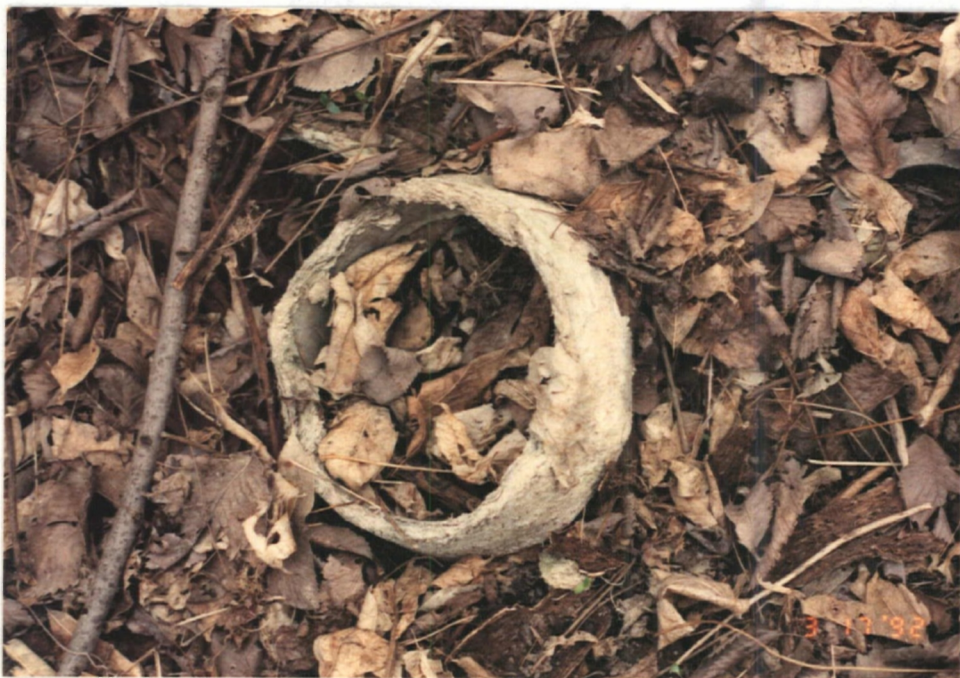
Photographer: Dave Kinroth
Date/Time : 3/17/92/1245
Lens: Type: 50mm/normal
Serial No.: 1063023
Frame No. : 12
Direction : NW
Comments :
Transite pipe and connectors,
north creek bank south of
former Certain-Teed

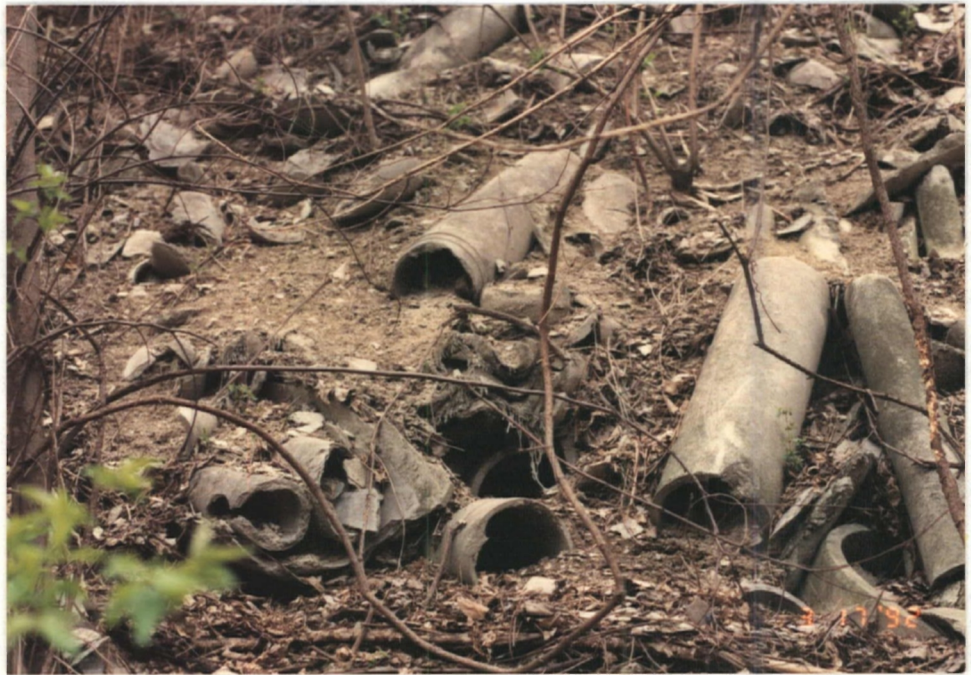
Photographer: Dave Kinroth
Date/Time : 3/17/92/1245
Lens: Type: 50mm/normal
Serial No.: 1063023
Frame No. : 13
Direction : NW
Comments :
Transite pipe and connectors,
north creek bank south of
former Certain-Teed
